Seismic Performance of Wine Caves

Andrew Kositsky and Scott Lewis Condor Earth Technologies, Inc.

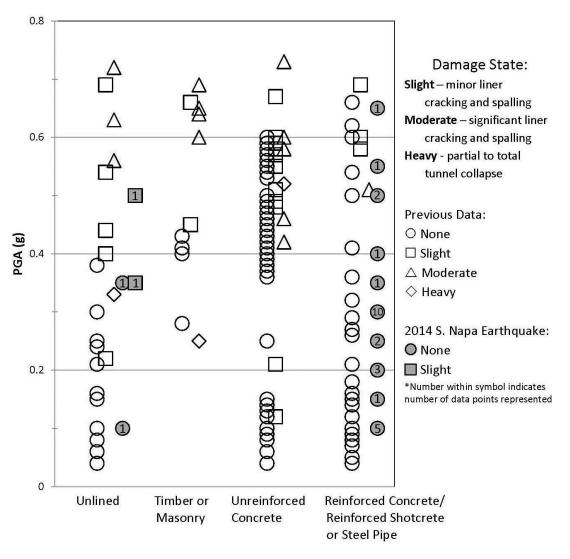
Figure 2 – Tunnel Damage State vs. PGA

Figure 2 plots the damage state and PGA of the cases compiled by Power and others (1998) and the new cases from the Napa event in each liner type category. We separated the plots for cases from the Napa event from the previous cases. Most of the new cases are for wine caves lined with welded wire fabric – reinforced shotcrete, and therefore, are in the "reinforced concrete/reinforced shotcrete or steel pipe" category. Some of the wine caves included have no liner or partially constructed liners, and therefore, are presented in the "unlined" category. We used the same definitions for damage state as did Power and others (1998), as summarized in the "Previous Case Studies" section of this paper.

For the reinforced concrete/reinforced shotcrete or steel pipe category, including the added wine caves with reinforced shotcrete liners, there are only 4 of 50 cases with slight to moderate damage for PGAs up to 0.7 g and no cases of damage with PGAs less than 0.5 g. For this liner category, the authors added four cases from the Napa event with PGAs over 0.5 g (for a total of 13 cases) and 23 cases with PGAs less than 0.5 g (for a total of 41 cases).

For the unlined category, the authors added four cases from the Napa event showing similar trends in damage state as the former cases compiled by Power and others (1998), as shown on Figure 2. No cases were added to the timber or masonry category and the unreinforced concrete category.
