ARTICLE

Thermal influences on spontaneous rock dome exfoliation

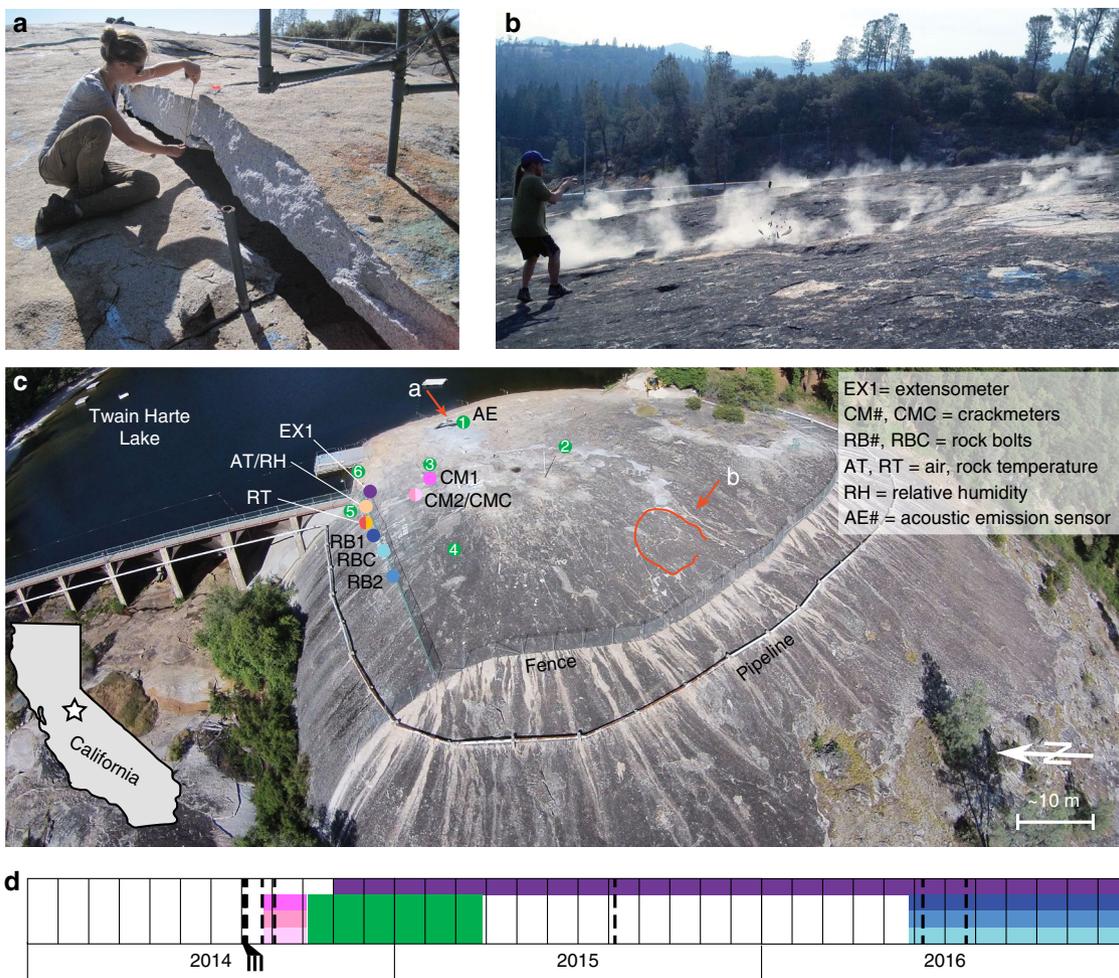
Fig. 1 Twain Harte Dome California and exfoliation events. **a** During the summer of 2014, spontaneous exfoliation caused 30-cm-thick exfoliation sheets to fracture and tent upwards. **b** Close-range video captured the explosive nature of one instance of exfoliation (full video available in Supplementary Movie 1). Fragments of rupturing rock are visible in the center of the image and rock dust emanates from the fracture boundary. **c** Overall dome is 100 m by 350 m with maximum vertical relief of 75 m to the west. Summit area (shown here) is symmetrical with 50 m radius and increases in curvature from 0.007 m⁻¹ at the summit to 0.027 m⁻¹ to the northwest. White streaking on rock results from snowmelt runoff collected at the base of a chain-link fence. Deformation (EX1, CM#, CMC), uplift force (RB#, RBC), air and rock temperature (AT, RT), relative humidity (RH), and acoustic emission (AE, 1-6) instruments monitored ongoing fracture. Arrows indicate view direction for **a** and **b**; red outline shows exfoliation area captured in **b**. Inset map shows location of study area in northern California, USA. **d** Timeline of deformation and acoustic monitoring instrumentation installation, colored as shown by symbols in **c**. Black dashed vertical lines are fracturing events. Image in **c** is © Robert J. Perry, 2015 and used with permission

Real-time exfoliation observations. Twain Harte Dome shares broad characteristics with the hundreds of other granitic exfoliation domes found in California, and elsewhere. Located on the western slope of the Sierra Nevada at an elevation of 1080 m (above mean sea level), the dome (Fig. 1) was not glaciated during the last glacial maximum^{33,34}. Spontaneous popping noises from Twain Harte Dome commenced in early August 2014, with fracture formation and propagation on its north side. Several exfoliation events occurred over the next few days (Table 1), but with differing locations (Fig. 2) and associated energy. On 6 August 2014, explosive fracturing thrust a 2 m by 5 m by 0.3 m sheet of granodiorite up to 44 cm upward, forming a tent structure (Fig. 1a). Rock fracture then continued for about 20 min, eventually shifting to the southwest with rock fragments thrown more than 4 m upwards (Fig. 1b, see also Supplementary Movie 1 and hyperlinks in Table 1). Two other exfoliation events occurred over the next month, but with lesser energy (i.e., smaller area of fracturing, Fig. 2) compared to earlier events. Our crackmeters (Fig. 3) and acoustic emissions (AE) monitoring (Fig. 1c), installed in late August and early October 2014, respectively, captured some of the post-exfoliation behavior.

Study area geology and dam history. Twain Harte Dome is one of several granitic domes⁵¹ located on the west slope of the Sierra Nevada Mountains of California (Fig. 1). The rock comprising Twain Harte Dome is a Mesozoic-age medium-grained granodiorite with an average grain size of ~1–2 mm (Supplementary Fig. 3). The rock dome forms the left (south) abutment of a 11-m-tall, 100-m-long, concrete multiple-arch dam that impounds 11 hectare-meters of water. The dam was constructed in 1928; inspection of pre-construction site photographs indicates the dome geometry did not significantly change as a result of construction except where the dam is keyed into the dome. The reservoir (i.e., Twain Harte Lake) is used for recreation during the summer months and pool level is generally kept full year-round—inflows from winter precipitation and spring snowmelt spill along the length of the dam crest to the west-draining creek on the north side of the dome. No anomalous activities related to the dam were noted by the lake manager (D. Wyckoff, 2014, personal communication) or local residents in the years, months, and days leading up to the beginning of recent exfoliation in 2014.

Acoustic monitoring. We installed six acoustic emission (AE) sensors (Physical Acoustics Corporation PK15I; AE1-6—Fig. 1c) on the dome using established methodologies⁵³. Monitoring occurred from 4 October 2014 to 24 March 2015, during which time the dam underwent repairs. The AE instrumentation was removed following construction activities and reopening of the dome to lake visitors. During the monitoring period, when the elastic wave measurement received from a single AE sensor exceeded a pre-defined threshold value (45 dB as suggested by the AE manufacturer for this application), data were recorded and referred to as an acoustic emission hit. Although AE monitoring of rock cracking under natural, non-loaded conditions is not common, it is increasingly undertaken with good results^{41,54–58}. Further, it is well-accepted from rock physics applications^{17,59} that hit rate is proportional to the damage incurred by subcritical cracking in rock. Here, the timing of each AE was processed using Physical Acoustics Corporation AEwin software; examination of other features of the AE signal (e.g., energy or amplitude) was beyond the scope of this study.

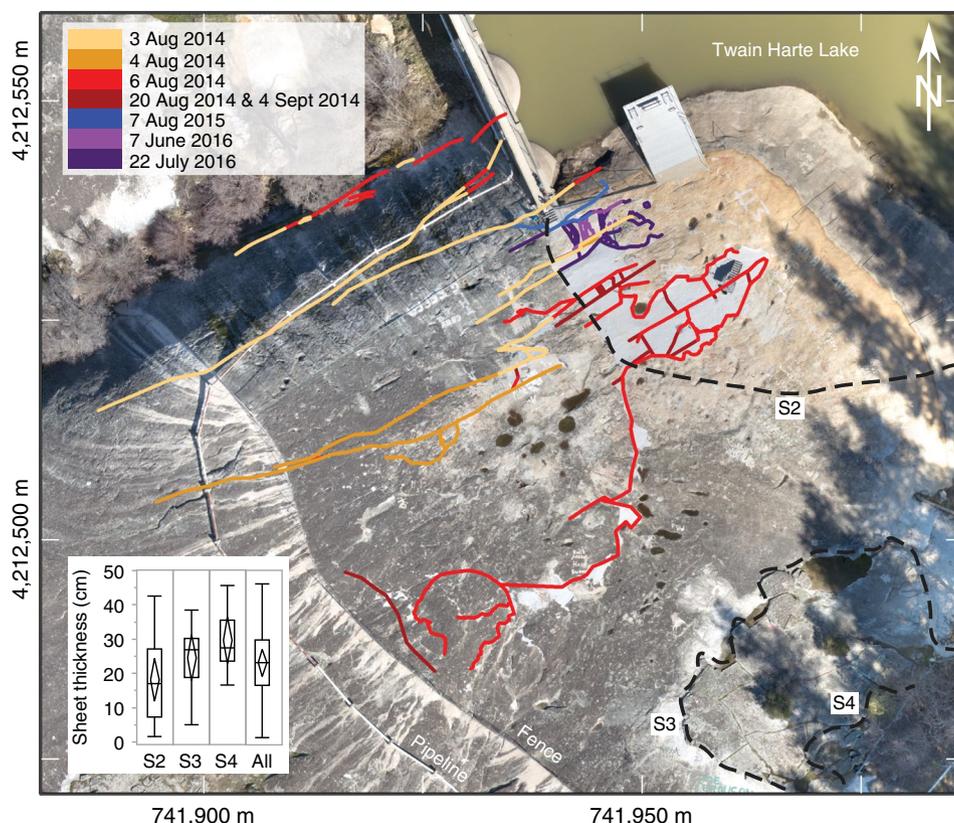
Fig. 2 Fracture mapping of recent and older exfoliation at Twain Harte Dome. Fractures (both surface-parallel and perpendicular) formed during events of 2014–2016—colored by date—indicate exfoliation progressed first to the south and then to the northeast. Mean thickness (inset), measured along transects (dashed lines—S3, S4), of past exfoliation sheets is slightly larger than the mean thickness of newly exposed sheets on the dome surface (S2), reflecting that thinner sheets formed during recent exfoliation and have eroded from older generations. Note that the top of sheet S1 (not labeled) is formed by the newly exposed exfoliation surface; its thickness across a transect cannot be easily measured. Base image (NAD83, UTM Zone 10 grid shown) created from UAS (drone) orthophotography as part of this study. Inset box-and-whisker plot elements: horizontal line = median; diamond = mean (center) and 95% confidence interval; box = 25th to 75th quantiles; whiskers = all data range

Additional fracturing occurred during the following summer (2015), but without the telltale explosive exfoliation previously observed. Then, in June and July 2016, two additional energetic exfoliation events occurred, buckling sheets up to 10 cm thick (Supplementary Fig. 1). Our rockbolt and extensometer equipment (Fig. 3), which had been installed in May 2016, captured the stress and deformation response. New exfoliation between 2014 and 2016 extended over a total area of 3030 m², displacing 2340 m³ of rock (Fig. 2).

Topographic and fracture mapping. We used terrestrial lidar and differential global positioning system (GPS) surveying to construct a high-resolution topographic model of the dome and to map visible surface fractures from the exfoliation events. Our lidar data set, collected using a Riegl Z420i laser scanner from 14 scan positions surrounding and on top of the dome, consists of 25×10^6 points of the dome surface. We collected fracture location data of the first four events using a pair of Topcon Hiper + dual-frequency RTK receivers—points on fractures were collected at ~1.5 m spacing along the visible aperture width (>~0.5 mm) of surface cracks. We updated this mapping using field observations made following the other exfoliation events and supplemented these observations with those provided to us by others (notably scale maps drawn by personnel from the California Division of Safety of Dams). During a field visit on 8 September 2014, we also measured the aperture, surface perpendicular depth, orientation (strike and dip), and sheet thickness (where measurable) along visible fractures. For base map generation, we collected high-resolution (1.65 cm per pixel), aerial imagery in March 2017 using a 3DR Solo unmanned aircraft system (UAS) with a Canon Powershot S100 (12.1 megapixels) attached in nadir position (i.e., pointing straight down). We processed this data using Agisoft Photoscan software (v.1.2.6) and achieved a 10 cm RMSE with 21 georeferenced ground control points.

Fracture stress intensity analysis. During the 7 June 2016 exfoliation event, rockbolt uplift forces across the partially attached, deforming sheet reached 33 kN and 95 kN at 25 m (RB2) and 15 m (RB1) distance from the nucleus of exfoliation (Fig. 2), and across minimum surficial sheet thicknesses of 1.14 and 0.71 m,

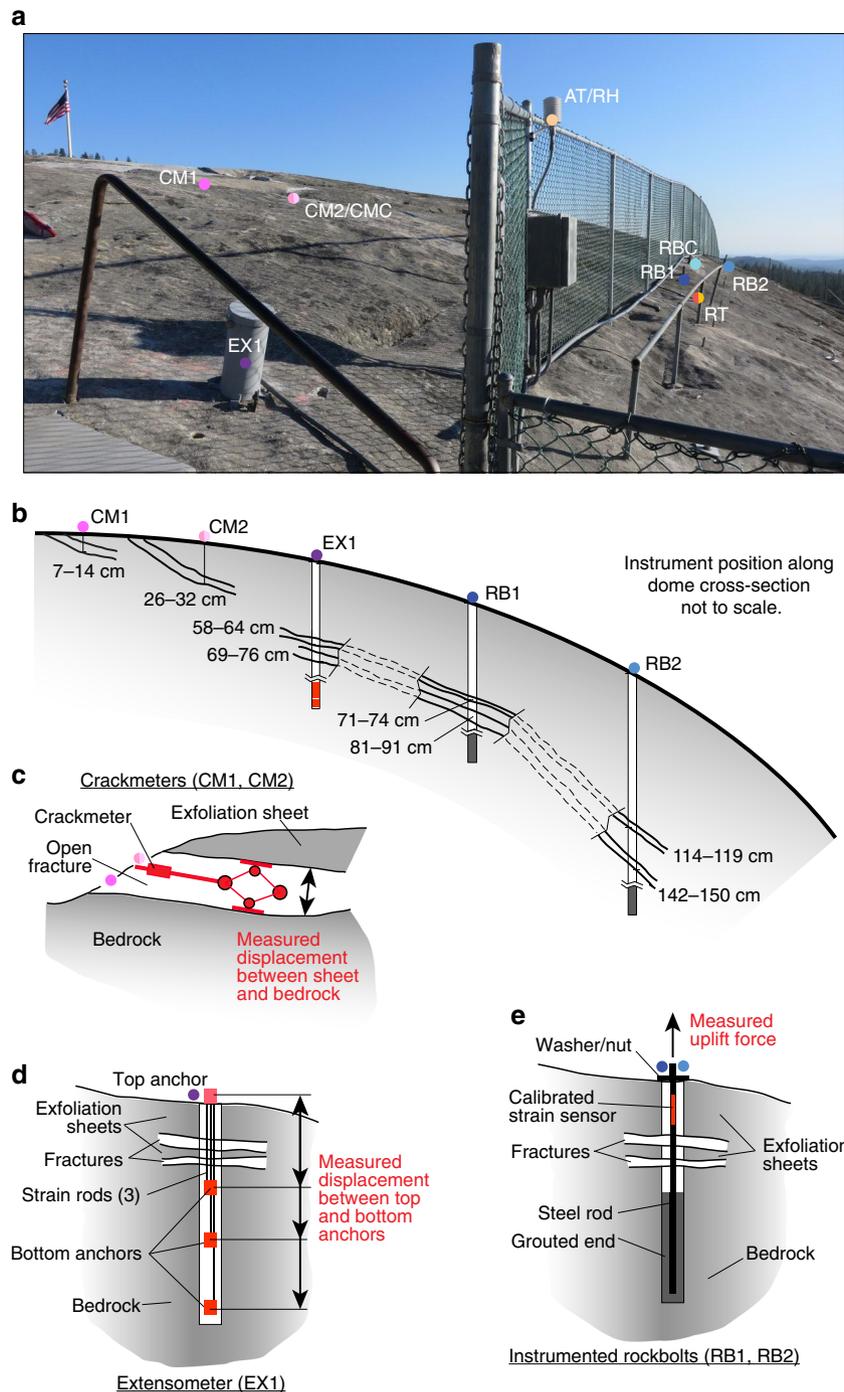
Fig. 3 Exfoliation dome instrumentation layout and schematic diagrams of deformation and force monitoring equipment. **a** A suite of instrumentation is deployed across the most active area of exfoliation. Symbols, instrumentation labels, and scale are as described in Fig. 1. **b** Instrument installations intersect several exfoliation sheet fractures at depth depending on their position across the dome. Fractures are open across the annotated depths and are to scale. Note that instrument positions along the cross-section are not to scale (i.e., the instrumentation is not in-plane as shown; see Fig. 1 and **a** for true spatial layout). Crackmeters, extensometers and rockbolts measure longitudinal strain, which is converted to deformations and force through linear elastic constants specific to the geometry and design of each instrument. **c** Crackmeters measure exfoliation sheet fracture aperture width by installation directly within fractures. **d** Extensometers measure exfoliation sheet fracture aperture width by installation across fractures through anchoring on either side of a fracture. In our extensometer installation, three instruments provide redundant measurements across the fractures. **e** Rockbolts measure exfoliation sheet uplift force generated along a steel rod that is grouted and fixed in bedrock at one end, and tightened to the surface of the deforming exfoliation sheet at the other end. Forces are converted to stresses through approximations of exfoliation sheet attachment geometry. See Methods for additional details for instrumentation installations

Deformation and environmental monitoring. To capture post-event deformation, we deployed two vibrating wire strain gage crackmeters (Geokon 4420-1x-50; CM1, CM2—Figs. 1c and 3c, Supplementary Fig. 4) in prominent fractures on the dome surface on 22 August 2014, 48 h after the fourth event. Depth (i.e., exfoliation sheet thickness) at CM1 and CM2 were ~7 and 26 cm (Fig. 3b), respectively, with

As part of the remediation of the dam, a single 5.6-m-deep, 3-channel extensometer (Geokon 4450 with accuracy of ± 0.02 mm) was installed on 17 November 2014 (EX1—Fig. 1c, Fig. 3d, Supplementary Fig. 5). Depth of individual channel installations were 0–1.7 m (Channel 1-1), 0–3.2 m (Channel 1-2) and 0–5.6 m (Channel 1-3). All three channels of the extensometer span two open fractures at 0.58–0.64 m and 0.69–0.76 m borehole depth (Fig. 3b) for a total combined fracture opening (6 cm + 7 cm) of 13 cm. However, the fractures soon grew larger, reaching a maximum of ~18 cm during the summer of 2015 (Fig. 4a). The extensometer was initially installed to periodically (at approximate 10 day intervals) measure potential deformation between the surface and three depths (1.7 m, 3.2 m, and 5.6 m) during the repair of the dam. We installed a data logger on the instrument on 17 March 2015 to collect high temporal resolution (5-min) data following the repairs. The sampling rate was then changed to 10-min on 24 May 2016. The signals between channels are nearly identical such that we only plot the uppermost channel (Channel 1-1) installed at 1.7 m depth. Data for all three channels are presented in Supplementary Data 1, which provides both raw (calibrated) and final (calibrated and temperature-corrected) signals using standard manufacturer protocols for temperature correction.

respectively (Fig. 3b). We assume that these uplift forces are directly related to thermal forcing due to their synchronous relationship with diurnal temperature fluctuations. Because the measured uplift forces act on a part of the sheet that did not fully rupture, we compute tensile forces at the crack tips of the rupture site by two methods, each involving an extrapolation of data from RB1 and RB2. The first method of computation assumes that tensile forces increase linearly with decreasing distance to the site of rupture (i.e., 95 kN–33 kN force difference over a 10 m span between RB1 and RB2 = 6.2 kN m⁻¹) thereby indicating that uplift forces are maximum at the site of fracture. The uplift force, U at the 7 June 2016 site is then 188 kN (95 kN at RB1 plus 6.2 kN m⁻¹ increasing over 15 m between RB1 and the site of exfoliation gives $U = 95 \text{ kN} + 6.2 \text{ kN m}^{-1} \times 15 \text{ m} = 188 \text{ kN}$). The second method of tensile stress computation assumes that the uplift forces are either linearly or exponentially related to the thickness of the slab (which thins toward the site of rupture). Assuming a linear relationship, and for the geometry at RB1 and RB2, we have uplift force $U = -144.2d \text{ kN m}^{-1} + 197.4 \text{ kN}$, and for a thickness $d = 0.1$ m, the uplift force is 183 kN. We can also fit an exponential function to the two data points from RB1 and RB2 (that is, RB1 load of 95 kN with 0.71 m sheet thickness and RB2 load of 33 kN with 1.14 m sheet thickness), which results in $U = 544.4 e^{-2.459d}$, which again for $d = 0.1$ m, results in $U = 426 \text{ kN}$. Thus, the estimated uplift force at the site of rupture using both of these methods is between 183 kN and 426 kN. Whereas we cannot know the magnitude of the uplift force at the crack tips of the rupture sheet with certainty, our measurements provide at least a guideline based on real data. Applying the computed force evenly across the geometry of the exfoliation sheet (7.1 m by 2.2 m; Supplementary Fig. 1), and noting from field observations that the sheet was only partially (50 to 75%) attached to the parent rock prior to fracture, the acting tensile stress change ($\Delta\sigma$) is between 16 and 55 kPa (full range of all estimates of U), which acts to open the exfoliation fracture in a mode I (tensile) direction. For the 7.1 m long sheet, the half crack width (a) is 3.55 m prior to the 7 June 2016 exfoliation. Implementing the stress intensity approach from linear elastic fracture mechanics theory⁴⁵ ($K_I = \Delta\sigma\sqrt{\pi a}$ for an idealized two-dimensional isolated crack), the resulting thermally generated stress intensity factor, $K_{I(\text{therm})}$ is between 0.05 and 0.18 MPa $\sqrt{\text{m}}$.

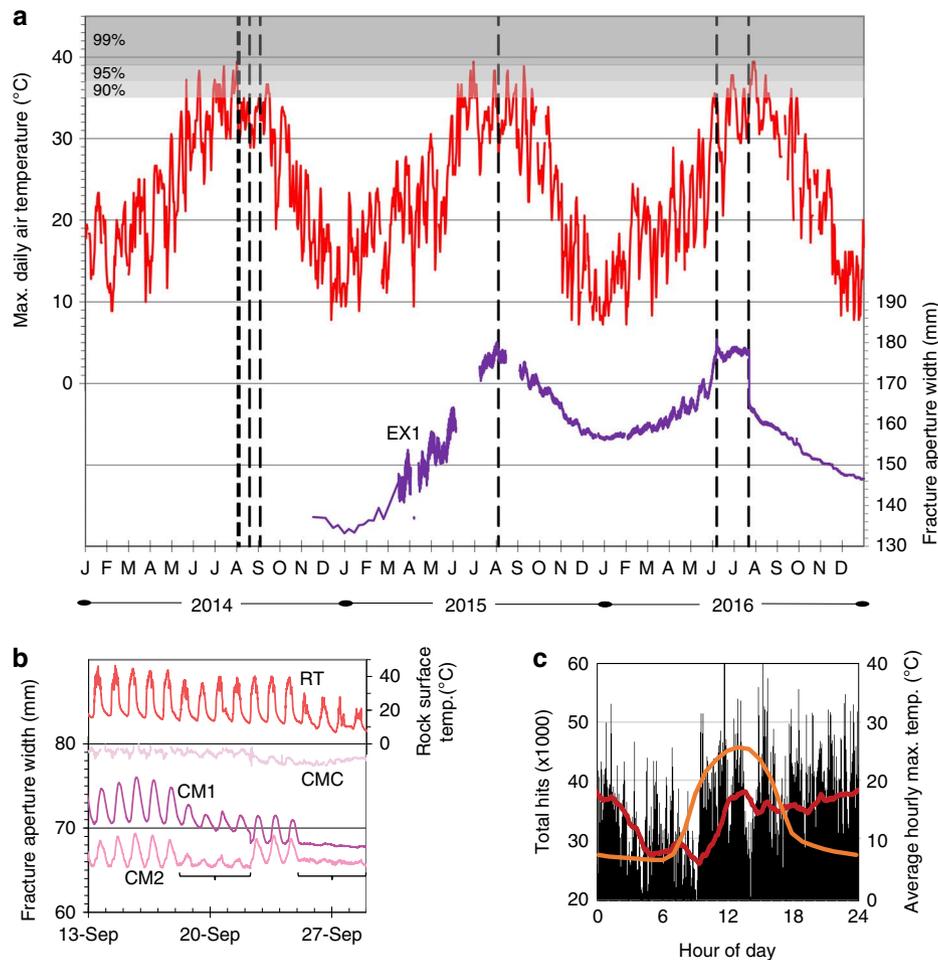
Fig. 4 Time scales of critical and subcritical exfoliation fracture propagation. **a** Sheet deformation (EX1) correlates with maximum daily temperature with shaded quantiles indicating that all fracturing events (vertical dashed lines) occurred within 10-day time periods containing the hottest 10% of all days during the past 110 years. Initial fracture in 2014 occurred within 24 h of temperatures reaching the 99th percentile of hottest days on record. **b** Following cyclic diurnal fracture growth (CM1 and CM2), one exfoliation sheet collapsed (brackets) in 2014. Control signal (CMC) indicates small overall error (1 mm) compared to the sheet signals. **c** Total acoustic emission hits ($n = 48.7 \times 10^6$) from six sensors (Fig. 1c) over 6 months (October 2014–March 2015) indicate subcritical cracking was ongoing following the 2014 events; sharp increase in 3-h hit running average (red line) peaks with maximum temperatures (orange line)

In all cases, fracturing occurred only during the summer (June through September) (Fig. 4a) and were preceded by 10-day periods with some of the highest temperatures on record near the site. In 2014, initial fracture occurred within 24 h of air temperatures reaching the 99th percentile of highest temperatures recorded (Fig. 4a). Rock surface temperatures were even higher (>50 °C) during these time periods.

Periods of subcritical fracturing are also indicated by AE data (Fig. 4c). These data record tens of thousands of AE hits that occurred on the dome (with hits taken as an indication of rock damage¹⁷), even during a period of exfoliation quiescence that followed the energetic and slow collapse events earlier in 2014. As such, this AE activity may have been a precursor to the visible fracturing observed later in 2015. At the hourly scale, AE signals show greatest evidence for microfracture in the afternoon and evening (Fig. 4c). Insolation-related subcritical fracture may occur at any time of day depending on the geometry and aspect of

fracture aperture widths of ~65 to 75 mm (Fig. 4b). An identical control device (CMC) was installed in a fixed position near CM2, but not in direct contact with the deforming exfoliation sheets. The gages measured expansion and contraction of the uppermost fractured exfoliation sheet to an accuracy of 0.05 mm and have been used in previous exfoliation studies²¹. These instruments collected data at 5 min intervals for a period of 42 days until they were crushed by detachment and collapse of the sheet. Raw sheet deformation signals (Fig. 4b) were well above the error level identified with the control device (1 mm) from thermal expansion of the device and vibrating wire sensor themselves. Crackmeters did not capture any signs of the fifth exfoliation event on 4 September 2014, presumably because of the event's small size (D. Wyckoff, 2014, personal communication).

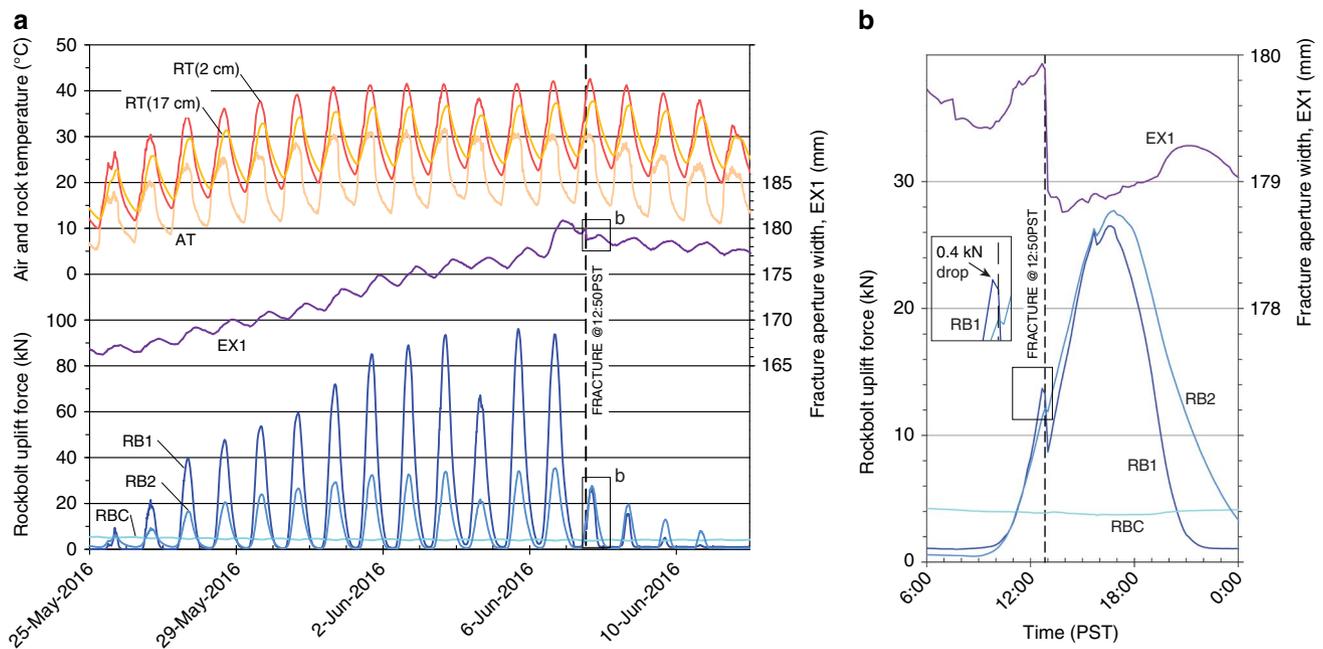
Fig. 5 Uplift signals and temperature response of uppermost rock sheet prior to the 7 June 2016 exfoliation event. **a** Rising air temperatures results in amplified rock temperatures, with slight (1–2 h) delays in temperature change and consequent increases in rock uplift forces and sheet deformation. When maximum temperatures level out (early June), uplift forces and deformation continue to increase until energetic fracture (dashed line). **b** Fracture was accompanied by a 1 mm instantaneous settlement of the uppermost sheet and force drop of 5 kN. Instrumentation subsequently continues to measure stresses from other parts of the dome. A possible precursor uplift force drop (indicative of an overall stress drop) was captured in the 10-min prior to energetic fracture (inset box). Instrument error ($2\sigma = 0.8$ kN) as determined from RBC is far below the uplift force magnitudes reached during this time. RB# rockbolt uplift force, RBC rockbolt uplift force control, EX1 extensometer deformation, AT air temperature, RT rock temperature (depth indicated); instrument locations as shown in Fig. 1

Overall sheet deformation on the north side of the dome (EX1) increased concomitantly with the rockbolt signals, with 14 mm of cumulative uplift (Fig. 5a). These signals closely tracked air and rock temperatures, although, notably, uplift forces and sheet deformation continued increasing even during a three-day period (1 June 2016 – 3 June 2016) in which maximum temperatures leveled off, suggesting that the rock dome cumulatively stores

We originally (from August 2014 to May 2016) measured near-rock-surface air temperature (as a proxy for surface rock temperature) using pendant-type data loggers (Onset Hobo UA-002-64) installed at five locations (north, east, south, west, and top) on the dome. Owing to construction activities related to dam repair, a full record is incomplete for any one sensor, but variability was small between sensors due to their close proximity and similar aspect. We thus present data only from the North sensor (RT, Fig. 1c) because it was closest to the majority of exfoliation events. In May 2016, we installed a solar-radiation-shielded air temperature and humidity sensor (Vaisala HMP60; AT/RH—Fig. 1a) and two drilled and epoxied rock temperature sensors (Campbell Scientific 107; RT—Fig. 1c) at 2 cm and 17 cm depth near the same location as the pendant logger on the north side of the dome. These instruments provide the data for Fig. 5 and for rock temperatures reported for the exfoliation events in 2016.
