Seismic Performance of Wine Caves

Andrew Kositsky and Scott Lewis Condor Earth Technologies, Inc.

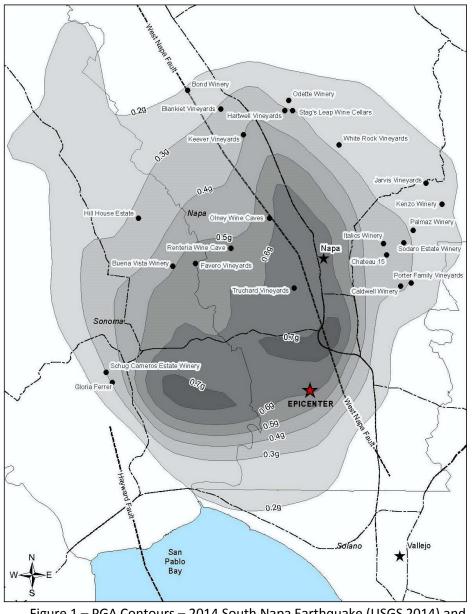
The South Napa Earthquake occurred at 3:20 AM Pacific Daylight Time on August 24, 2014. Figure 1 shows the approximate location of the epicenter, the measured/estimated PGA contours, and the location of wineries with wine caves added to the database where the PGA was at least 0.2 g.

Figure 1 – PGA Contours – 2014 South Napa Earthquake (USGS 2014) and Winery/Wine Cave Locations
